EXPERIMENTAL AND ANALYTICAL INVESTIGATIONS ON FLEXURAL PERFORMANCE OF CORRODED RC BEAMS USING RBSM-BASED CORROSION MODEL

Abstract - Residual strength and structural performance of reinforced concrete (RC) structures subjected to rebar corrosion need to be precisely evaluated for an efficient rehabilitation process. However, the performance of deteriorated structures cannot be specified by using design methods since the damaged conditions are different in each type of structures due to corrosion degree, corrosion position, environmental condition. This study first presents an experimental investigation on the flexural performance of RC beam subjected to rebar corrosion. To complement the test data, an analytical corrosion model developed by the authors, which is based on Rigid Body Spring Method (RBSM), was employed. The results obtained from both analytical model and experiment confirmed that the corroded beam appeared to obtain a significantly lower bending stiffness and lower flexural capacity than those of the sound beam. The developed corrosion model can be able to capture the load-displacement curve of experimental results with good agreement.

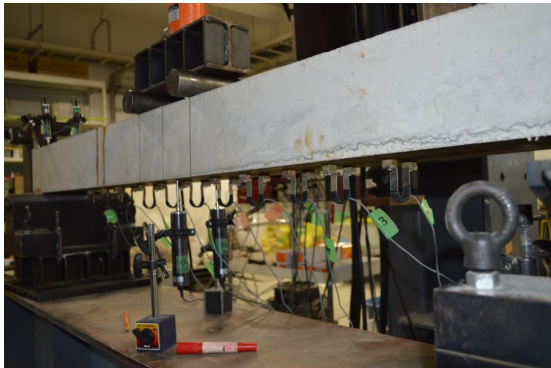
Figure 9. Test set-up

After finishing corrosion test, the beams were then loaded under four-point loading, as shown in Figure 9. Crack gauges were arranged at the middle of the beam to measure the crack width (Figure 10). For the instrumentation plan of the tests, three linear variable displacement transducers (LVDTs) were installed at the bottom of the HSS section at the mid-span (LVDT-1) and at the loading points (LVDT-2 and 3) (Figure 9). All the beams were tested under displacement control at a rate of 0.5 mm/min until the beam was yielded. The loading rate was then increased to 1 mm/min and kept continuing until a mid-span deflection of approximate 40 mm was reached. During the test, data were recorded once every 10s by the automatic data logger system. Load–displacement relationship and crack pattern at failure of sound beam and B1400-10% beam are plotted in Figures 11 and 12.

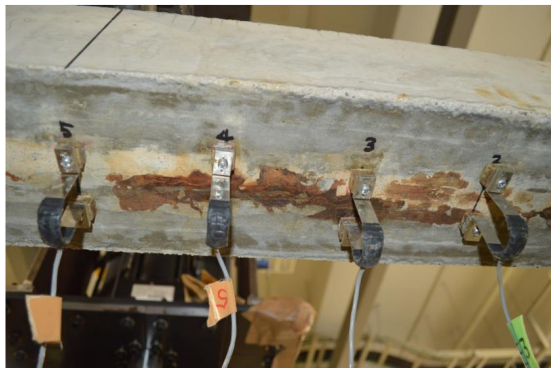
Figure 10. Crack gauges at the middle of the beam

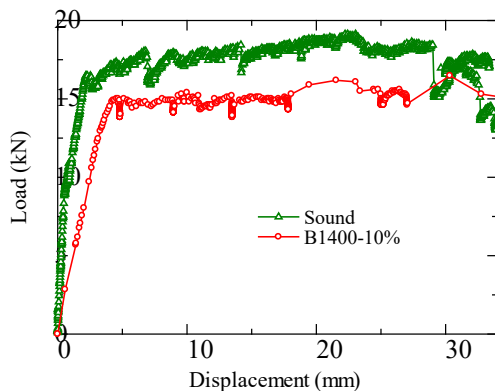
Figure 11. Load – displacement relationship in sound and corroded B1400-10% beams

It has been shown that both beams failed in flexure and sound beam appears to obtain higher flexural capacity and higher bending stiffness than those of corroded beams. As mentioned earlier, this significant difference should not be accounted for the difference in mechanical properties, which is only 1.7% for flexural capacity and 2.3% for initial stiffness. It seems that due to corrosion, bond strength in corroded B1400-10% beam was decreased. This effect combined with bond crack and reduction of rebar's area due to corrosion resulted in the significant degradation in bending stiffness and flexural strength.

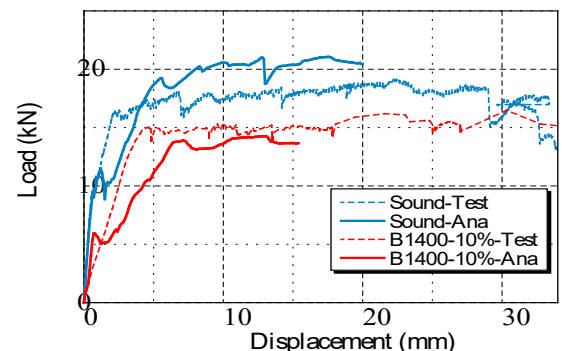
Figure 15. Load – displacement relationship obtaining from analysis in comparison to experiment

Figure 15 shows the load–displacement relationship curves obtaining from analytical model versus experiment. In sound beam, despite having a bit higher in flexural capacity, analytical results show a good correlation with test in terms of stiffness and failure mode. Pre-cracked load of analytical model almost coincides with experiment. When a crack occurred, the load was reduced slightly and then increased again until the beam reaches its flexural capacity. On the other hand, in corroded B1400-10% beam, when the load is still low, the load – displacement curve shows almost no difference with that of sound beam. Thereafter, when the first flexural crack occurred, the load was decreased and then increased again; however, it could not reach the same stiffness as before and finally failed at the earlier flexural load. Figure 16 exhibits that crack patterns at failure of both beams obtained by the analytical corrosion model are similar to test results.

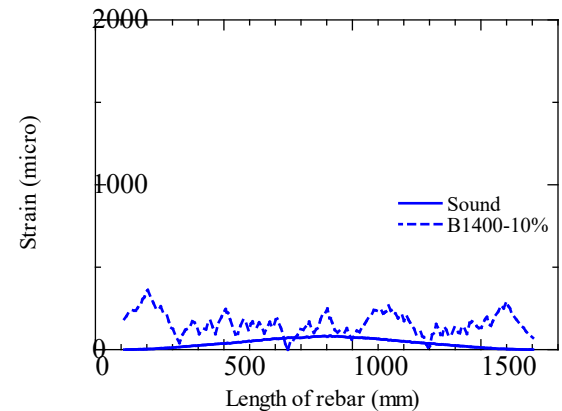
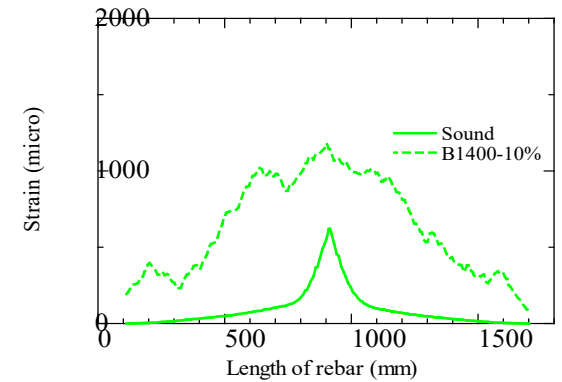
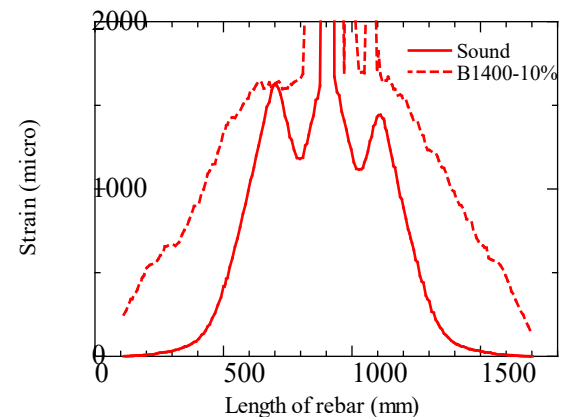
a) Load – displacement curve obtained from analysis

b) at 4kN

c) at 11kN

d) at peak load

Figure 17. Strain distributed along the rebar at several loading levels

Figure 17 shows a piece of evidence that high strain value is distributed along the rebar at every typical loading stage. It is indicated that at the load of 4 kN and 11 kN, while strain in sound beam distributes linearly, strain in corroded rebar in beam B1400-10% appears unstable tendency, which has proved that due to bond strength reduction, stress in rebar could not be transferred to concrete and causes high strain in rebar. This result once again confirmed with experimental result that due to the reduction of bond strength combined with corrosion crack and reduction of rebar’s area, beam’s bending stiffness was decreased and consequently the beam failed at early flexural strength. At peak load (Figure 17d), rebars in both beams are yielded, meaning that flexural failure occurs in these two beams. In all these stages, rebar’s strain in beam B1400-10% was always significantly higher than that in sound beam.
