PROCEDURE FOR DETERMINING THE CAUSE OF RIVERBANK PROTECTION INCIDENTS IN VIETNAM

Abstract - The main goal of this research is to describe the scientific process for identifying the causes of incidents in riverbank protection works in Vietnam. The process is carried out in main steps, including establishing an investigation team with appropriate expertise, conducting field surveys, collecting documents related to design and construction, and performing technical analysis experiments. Each stage in the process plays an essential role in clarifying the factors leading to incidents, from direct causes such as excessive currents, to indirect causes such as design errors or incorrect construction. The research proposes solutions to enhance the works' quality and longevity based on the data gathered and analyzed, which helps to minimize the risk of damage and prevent such occurrences in the future.

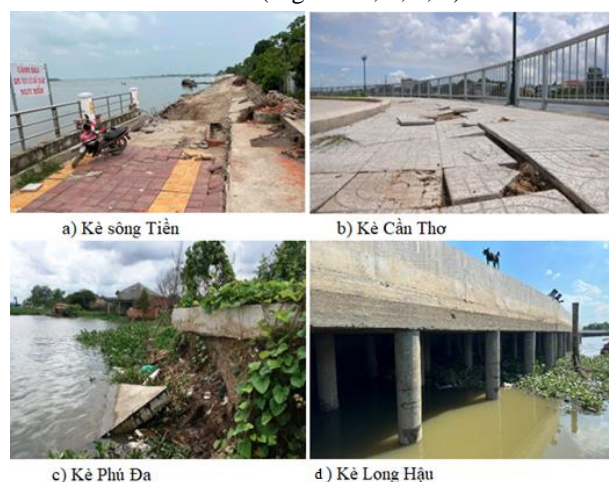
Figure 1. Some typical images of embankment incidents

southern bank when the project was about to be completed for handover. [3]. Similarly, the embankment project in the Resettlement Area - Long Hau Residential Area, along the right bank of Rach Doi River, Long Hau Commune, Can Giuoc District, Long An Province, had cracks appearing on the pile system after only about 6 months of construction (Figure 1a, b, c, d).
